# Suspender Cable Inspection Using Advanced Robotic Technology at Arrigoni Bridge

IBC-19-33

ABSTRACT: This paper covers the suspender cable inspection of Arrigoni Bridge 00524 using the advanced robotic technology - RopeScan®. This technology uses a Laser Vibrometer to determine the actual tension forces of the suspension cables under deadload conditions without any interference to traffic and minimal inconvenience to the traveling public.

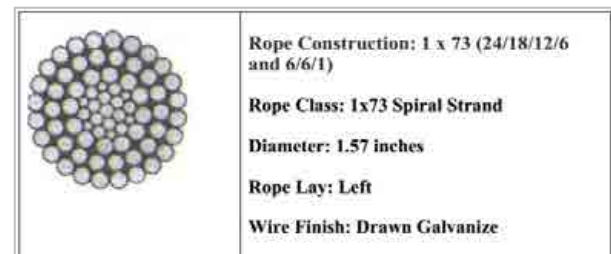
- suspender cable (Total 17 x 4 x 4 – 272 vertical with lengths ranging from minimum 6 ft., up to 100 ft.)

**FIGURE 3 – Cable Configuration (Typical)**

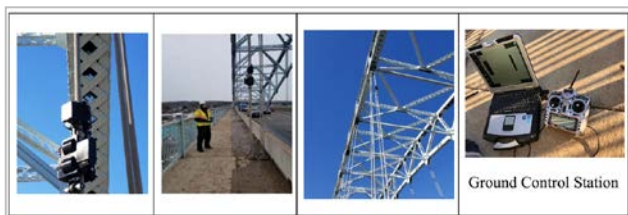
IPC performed the inspection using its RopeScan Robotic Inspection System. RopeScan is a stand-alone, battery operated, self-propelled wireless inspection system. It uses a clamshell approach to attach to the ropes. It is remote controlled and transmits test data to the ground station while scanning the rope for real-time viewing. RopeScan's tractor system can scan 70ft per minute with a mount and dismount time of one minute.

**FIGURE 4 – RopeScan Testing System**

A hand-held remote control was used to ascend and descend of RopeScan as it performs an inspection using MFL. The average time to test four ropes was approximately 20 minutes.

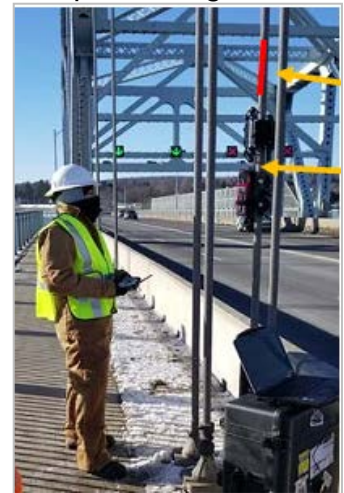
RopeScan was calibrated at the beginning of each day. A small wire representing a 1.2% section of the rope was attached to the outside of the rope. As RopeScan passed over the calibration rod the screen reflected an amplitude equal to the 1.2% increase in mass. This represents 0.4842 sq. inches of the rope.

**FIGURE 5 – Showing On-Site Calibration**

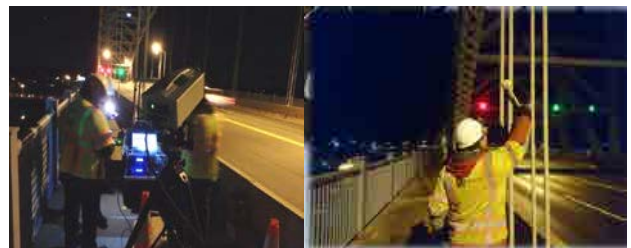
All measurements were conducted by using a Laser Vibrometer Type PSV-150. The advantages of using a Laser Vibrometer versus accelerometer system is the speed of mobilization and the ease of use. While accelerometers must be physically mounted onto the structure to obtain a vibrational reading, a Laser Vibrometer only requires pointing of the Laser beam onto the location where the measurement shall be taken.

The measurement was contactless and locations up to 200m (600ft) distance was measured without physically attaching any device or target onto the object of interest.

**FIGURE 8 – Tension Force Measurement of Suspender Cables**
